TB2056

Crankshaft Thrust Faces – Severe Use Recommendations

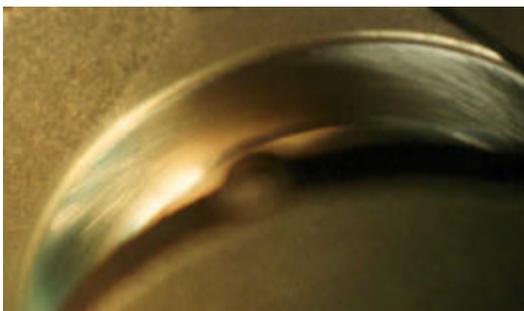
**AVOID - SWIRL PATTERN**

Obtaining a good finish on the thrust face of a crankshaft is difficult to do because it uses side-wheel grinding. Side grinding causes marks that spiral outward toward the OD of the thrust face and may also cause crosshatch marks resembling honing patterns. Both patterns are detrimental to the formation of an oil film because they work like wipers as the shaft rotates. **Grinding marks must be removed by polishing. Only a circular pattern should remain. Surface finish should be checked in a tangential direction and must be held to 10 Ra max. The thrust surface should be flat within .0002” max.**

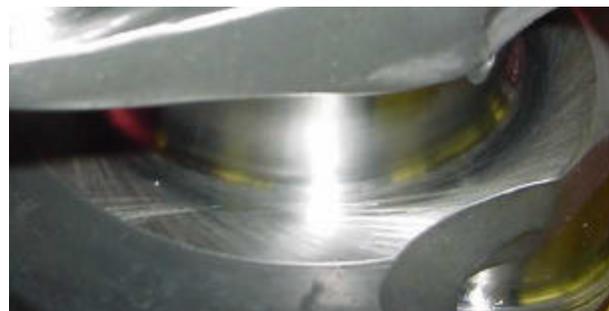
**AVOID - CROSSHATCH PATTERN**
